HISTORIC AMERICAN TIMBER JOINERY

A Graphic Guide

VI. Scarf Joints

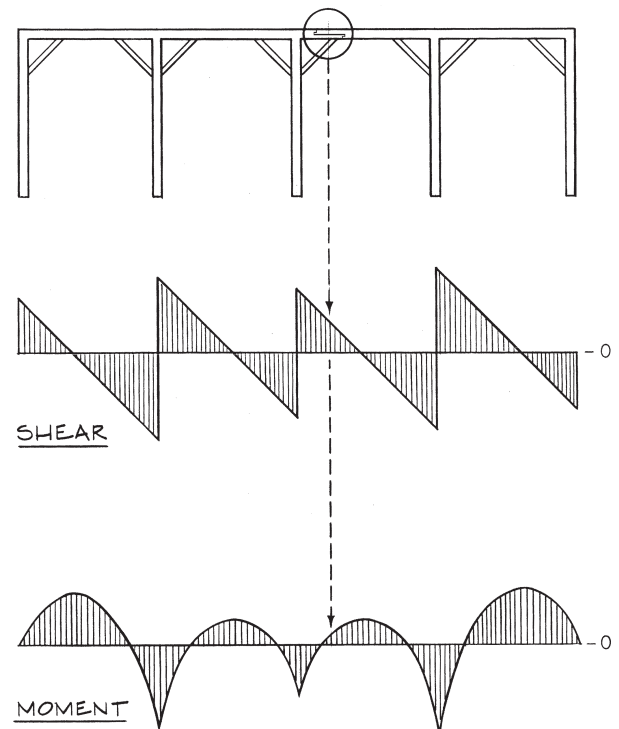
Fig. 1. Elevation of a plate continuous over five posts, showing a typical scarf location. Diagrams show resultant shear and moment values, both positive and negative, with horizontal line at zero force.

A member such as a plate or purlin plate that continues over multiple supports is much stiffer and stronger than one spanning between only two supports. The locations of the maximum and minimum moment (bending) forces are different in the continuous member. In a simple spanning member, the greatest moment occurs in the center of the span. In a continuous member, it occurs over the posts (Fig. 1, facing page).

Since it is difficult to create a scarf that handles bending forces as well as a solid timber, it makes sense to locate the scarf at a point where moment is the lowest. That is precisely where the majority of scarfs are located in old buildings. As in the illustration, the joint, additionally supported by the brace, is located where both shear and moment are low. Locating the scarf over the post, where stresses are at their maximum, would cause the plate to act like simple spanning members. Thus the plate would require a larger cross-section. Scarf location is also affected by available timber lengths and by the raising sequence of a building.

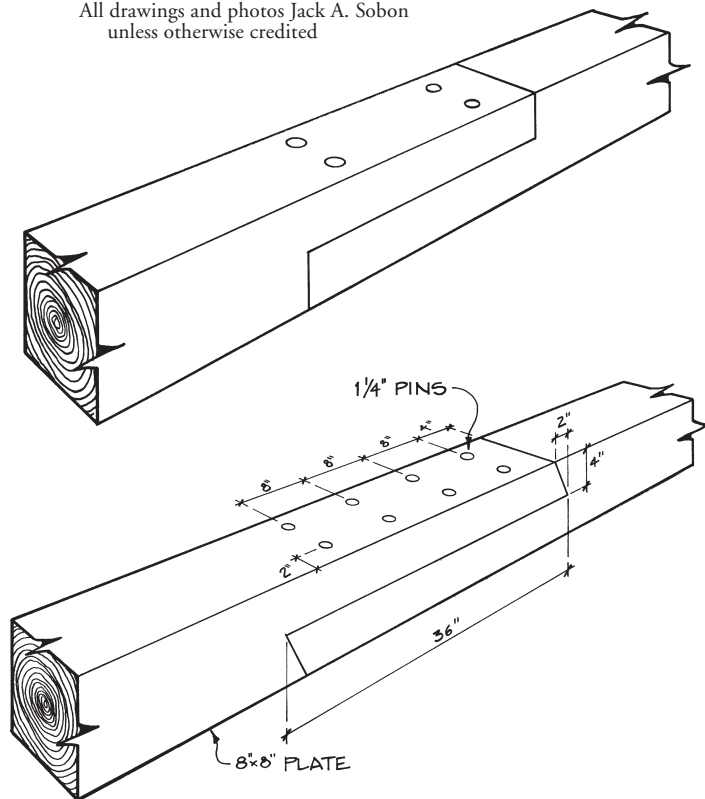
Figs. 2 and 3. At top (2), a halved scarf with four pins. Above (3), halved and undersquinted scarf found in an early-19th-century barn in Monterey, Massachusetts, the barn's only scarf; perhaps necessitated by some oversight in timber procurement. It has held up well despite its location in the center of the span. Note the 1-in-2 angle of the squint.

Halved Scarf. A basic halved scarf or half-lap (Fig. 2) is probably the simplest to fashion and thus the most abundant. It performs well in axial compression but depends solely on pins or bolts to resist tension and torsion. It has moderate shear strength but little

Halved and Undersquinted. To improve bending strength and resistance to seasoning twist, the ends of a scarf can be undersquinted (Fig. 3 below left). The angle most often encountered for the squint is 1 in 2. Shallower angles are more time consuming to cut and increase the likelihood of splitting at the notch. This joint is only slightly more work than the unsquinted version, but a considerable improvement. Pins are essential to the joint's effectiveness.

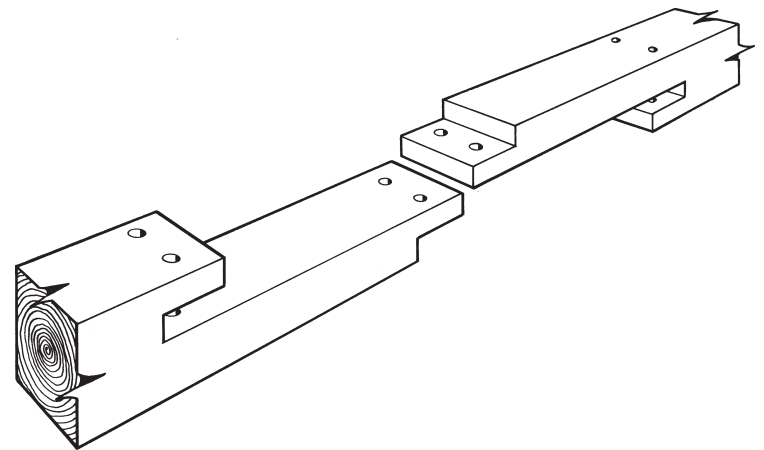
Fig. 4. Halved and bladed scarf with pinned tenons. Pins are often fitted additionally or alternatively in the central lapped portion.

Halved and Bladed. This common scarf is found in all periods and locales. Though most often used as depicted in Fig. 4, in early Massachusetts Bay frames it is frequently found on edge. The barefaced tenons prevent twisting and improve bending and tensile strength. Some builders added extra pins in the central lapped portion. Overall length is commonly four times the depth of the timber. Variations of this scarf may present stub tenons without pins or a shortened lapped portion. In one variation, the topmost and bottommost cuts are aligned vertically and the tenons lengthened (see Cummings, Fig. 86 and Hewett, Fig. 271). Tenons are typically 1½ in. or 2 in. thick, and 4 in. or 6 in. long.

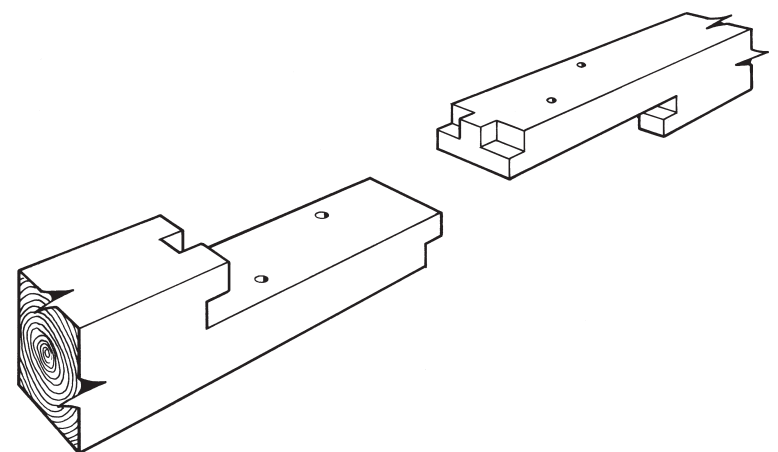
Fig. 5. Bladed and cogged scarf found in a barn along the Mohawk River in New York State. Drawn from memory.

Bladed and Cogged. In this unusual scarf (only one historic example found, though modern ones exist), a cog is provided in the T-shaped stub tenon (Fig. 5). This helps align the scarf and increases its bending strength against horizontal loads (such as rafter thrust), while adding some cutting time.

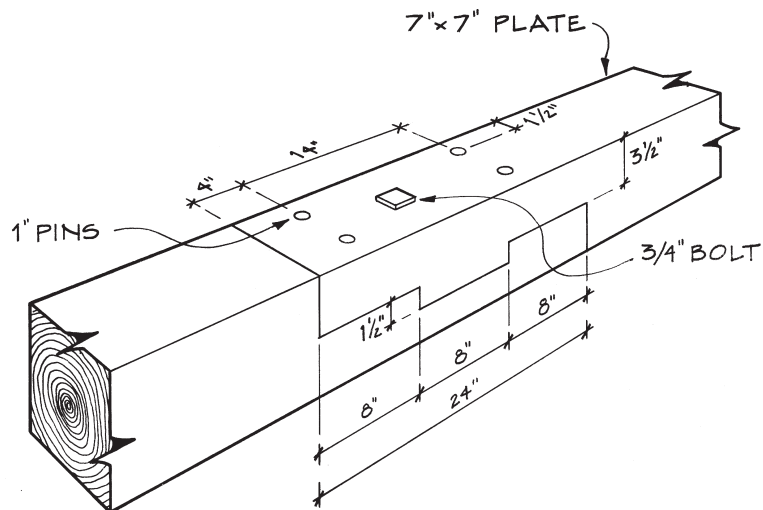
Fig. 6. Halved and tabled scarf in a 25x35-ft. three-bay 1860s barn in Windsor, Mass. This simple, effective joint relies on one bolt to keep it together.

Halved and Tabled. With its center “table,” this joint (Fig. 6) adds tensile capacity to the basic half lap. An iron bolt prevents twisting and displacement.

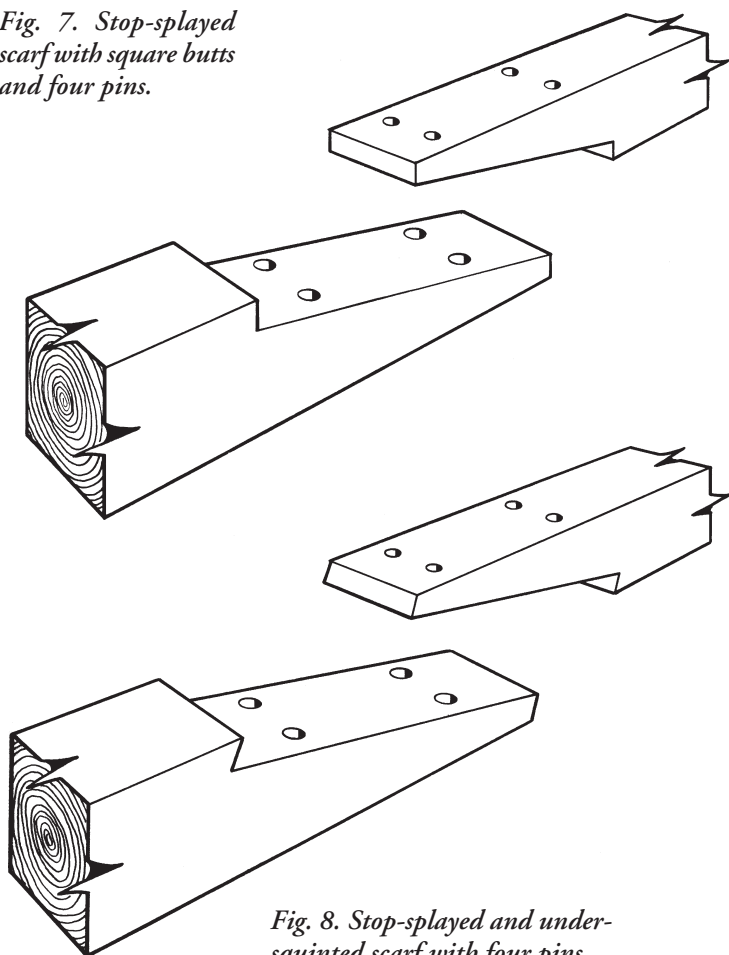
Fig. 7. Stop-splayed scarf with square butts and four pins.

Fig. 8. Stop-splayed and undersquinted scarf with four pins.

Splayed and Stop-Splayed. In its most basic form, this scarf is simply a pair of complementary straight sloping cuts secured to each other with pins, nails or bolts. Nicknamed the *whistle cut*, it works wonderfully in shear but relies upon fasteners for resisting axial loads and twisting. (See TF 59, page 13.) In its more common form, the sloped, lapped portion is stopped before it feathers out to nothing (Fig. 7). Compared with the half-lap, shear strength is vastly improved by the sloped surface. The square abutments, typically 1 1/2 in. or 2 in., resist axial compression. The pins provide tensile and torsion resistance.

Stop-Splayed and Undersquinted. Again by undersquinting the butts, the stop-splayed scarf (Fig. 8) is made more resistant to twisting. This scarf performs well, considering its ease of cutting.

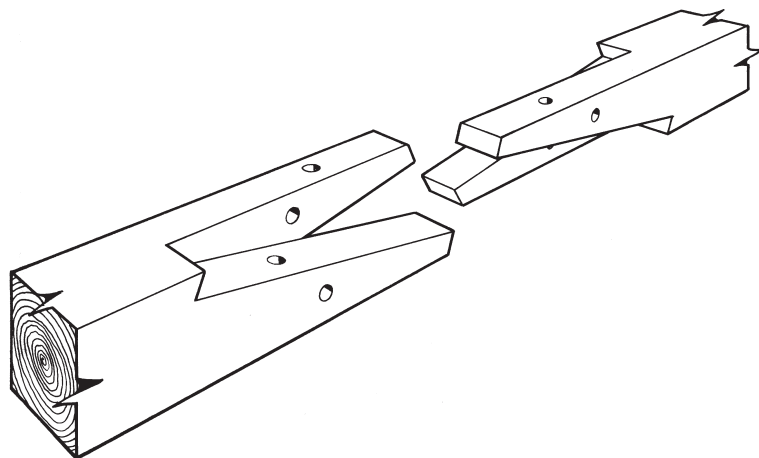
Fig. 9. Stop-splayed scissors scarf with two pins in each direction. The only known example is a 1927 repair to a house in Nantucket, Mass.

Stop-Splayed Scissors. While based on the stop-splayed and undersquinted scarf, this variation is much stronger (Fig. 9). However, it is disproportionately more time consuming to fabricate, which accounts for its rarity.

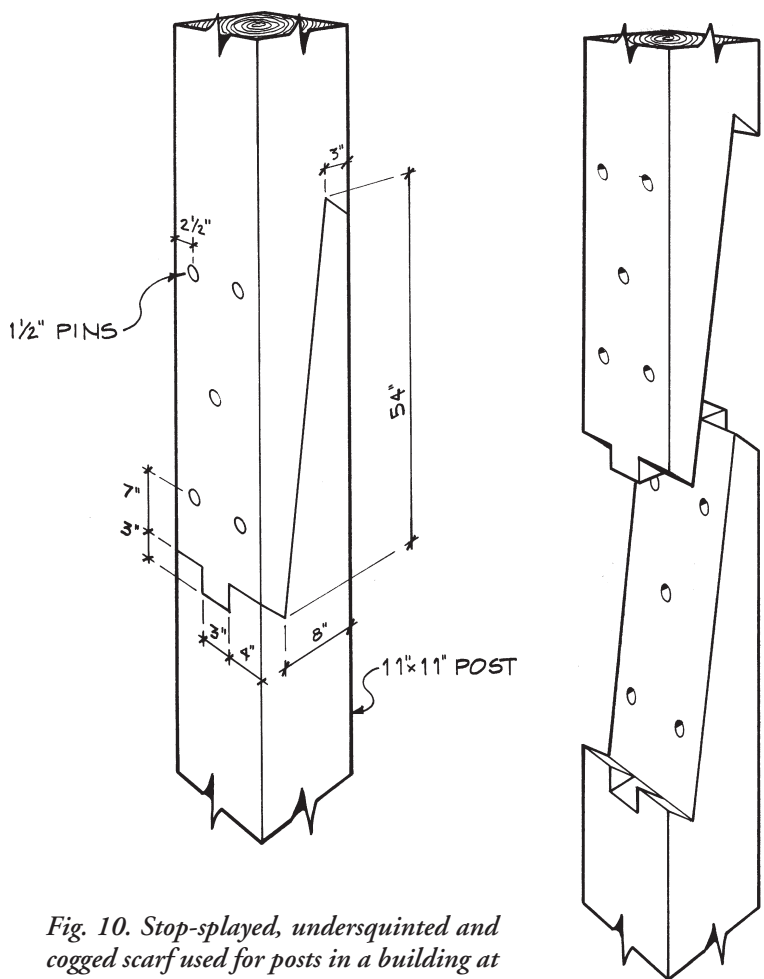
Fig. 10. Stop-splayed, undersquinted and cogged scarf used for posts in a building at Hancock (Mass.) Shaker Village, 1835. Apparently original, these joints are still tight. Note squint angle of 1 to 1.

Stop-Splayed, Undersquinted and Cogged. Adding a cog to the stop-splayed and undersquinted scarf improves its bending strength in the secondary direction (Fig. 10). Only one example has been found of this type.

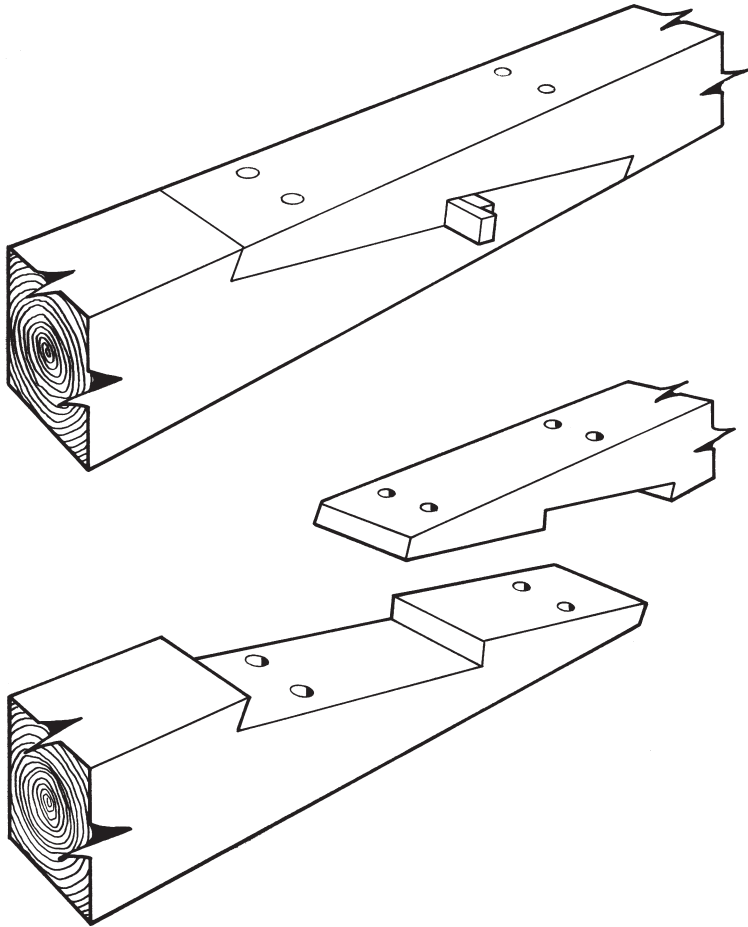
Fig. 11. Assembled and exploded views of stop-splayed, undersquinted and wedged scarf with four pins. Folding wedges pre-stress the joint.

Stop-Splayed, Undersquinted and Tabled with Wedges. A very strong scarf results when tabling and wedges are added (Fig. 11). The tensile capacity, torsion, and bending strength in both directions are greatly increased. The pins position the halves while the opposing wedges are driven and increase the joint's overall performance. The wedge thickness and the depth at the butts are usually the same, typically 1½ or 2 in. The butts need not be undersquinted. An example found at Jack's Valley, Nevada, has square butts, and bolts hold the scarf together.

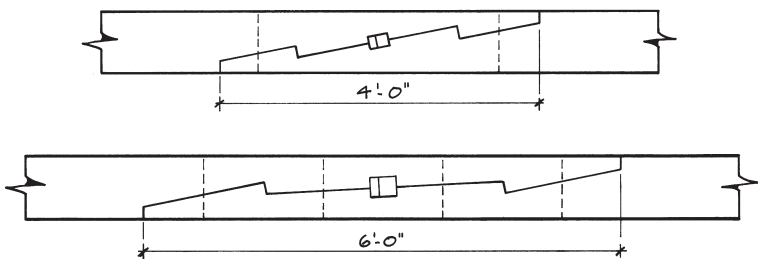
Fig. 12. Examples of the stop-splayed scarf with wedges and multiple tables, both taken from lower chords of trusses. The 4-ft. scarf was found on a late-19th-century building 40 ft. wide in Clayton, New York. The 6-ft. scarf was used in a ca.-1882 locomotive shop in Jamaica, N.Y., 64 ft. wide and 520 ft. long, and cut from 7½ x 9½ hard pine timber. Both scarfs use 1-in. bolts to keep the multiple bearing surfaces engaged. Both are designed for high tension loads.

Stop-Splayed with Wedges and Multiple Tables. By drawing out the scarf, additional tables can be added to increase tensile capacity (Fig. 12). The complexity of this scarf precludes its use except in members under great tensile loads, as in the lower chords of long-span trusses.

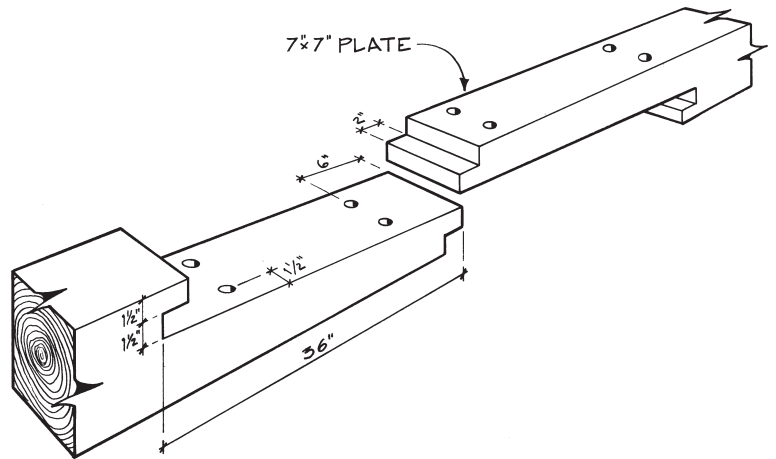
Fig. 13. Stop-splayed and bladed scarf in a late-19th-century 40x48-ft. barn in Windsor, Massachusetts, with stub tenons and four 1-in.-dia. turned pins. The slope of the splay is only 1 in 36.

Stop-Splayed and Bladed. By combining the bladed form with the splayed, the capacity of each is improved (Fig. 13). The tenons can be stub or long enough to be pinned. Compare Fig. 4.

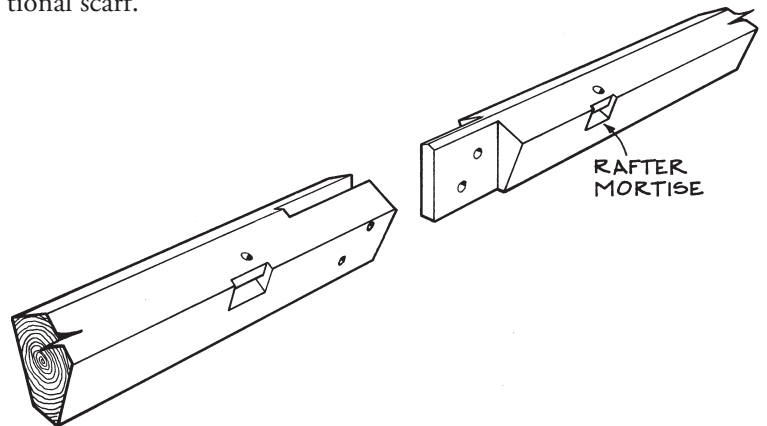
Fig. 14. Typical bridled scarf in a ridge beam. This short scarf works well where it receives frequent support from the rafters and must fit in the relatively short space between them.

Bridled. The simplest bridled joint is a tongue and fork or open mortise and tenon (Fig. 14). Though it doesn't handle loads other than axial particularly well, it still has advantages. Because it is typically fairly short, it uses less timber and can fit better between other joints. It is commonly found in ridge beam splices where the close spacing of the rafter mortises leaves little room for a conventional scarf.

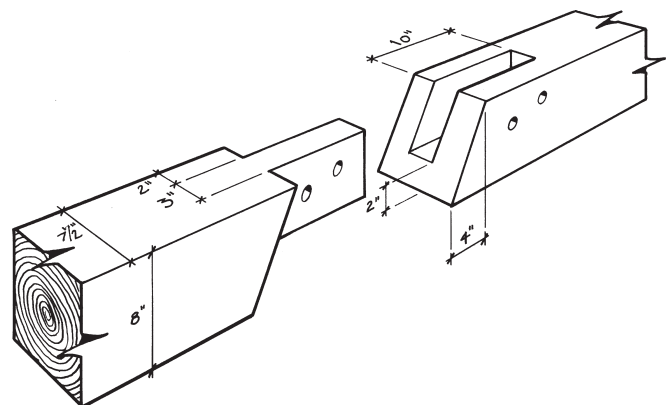
Fig. 15. Bridled and squinted scarf used (or reused) in the tie beams of the Harlow Old Fort House, Plymouth, Mass., ca. 1677.

Bridled and Squinted. The joint is improved by making the tenon blind on one edge and angling the abutment (Fig. 15). This

joint is also found where the abutment slopes the opposite way (see Cummings, Fig. 87), and in that form occurs in one of the oldest timber-framed buildings in England, as a sill scarf in the Barley Barn at Cressing Temple, ca. 1200 (see Hewett, Fig. 273). The use of this particular joint in the roof of Harlow Old Fort House in Plymouth, Mass., is odd: the scarfs, which do not perform well in bending, are located about 4 ft. from the ends of 27-ft. tie beams. But tradition says the house was framed of timbers taken from the original fort in the settlement, hence the scarfs.

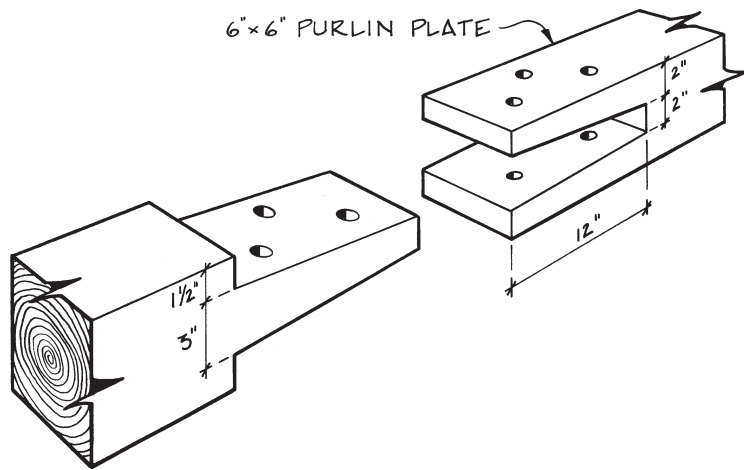
Fig. 16. Tapered bridle scarf in the purlin plates of a barn in Holliston, Massachusetts.

Tapered Bridle. This bridled scarf (Fig. 16), set flatwise, improves the shear capacity of the scarf. While it resists compression, moderate tension, and torsion, it is limited to locations where bending forces are minimal.

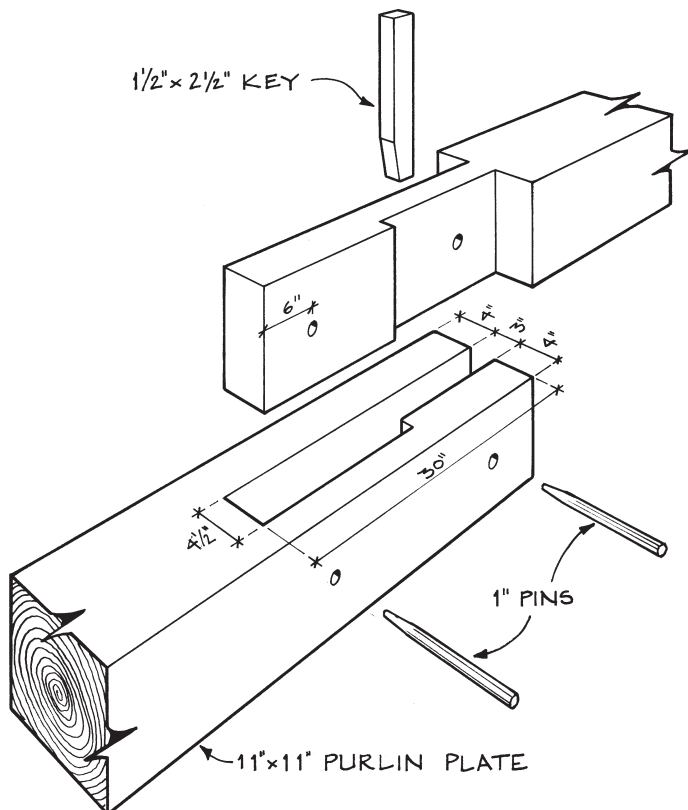
Fig. 17. Tabled and bridled scarf with key, 5-bay barn, 62x81 ft., Genoa, Nevada, ca. 1858.

Tabled and Bridled with Key. Lengthening the bridle to provide a table and key improves the tensile and bending performance of the scarf (Fig. 17). Its rarity seems to indicate that the extra strength is not sufficient to warrant the extra cutting work.

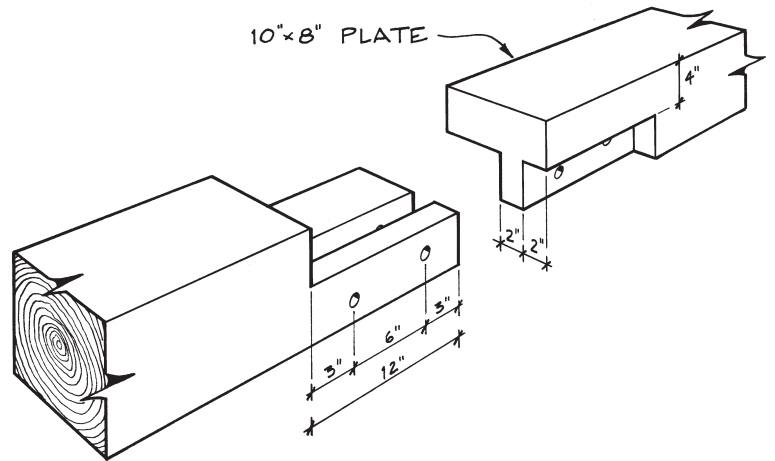
Fig. 18. Stop-Bridled Halving in a German barn, Myerstown, Penn. Located a very short distance from a post, it carried mostly shear force.

Stop-Bridled Halving. Only one example of this type (Fig. 18) has been located. Though it works moderately well in most conditions, weakness in bending limits its applications.

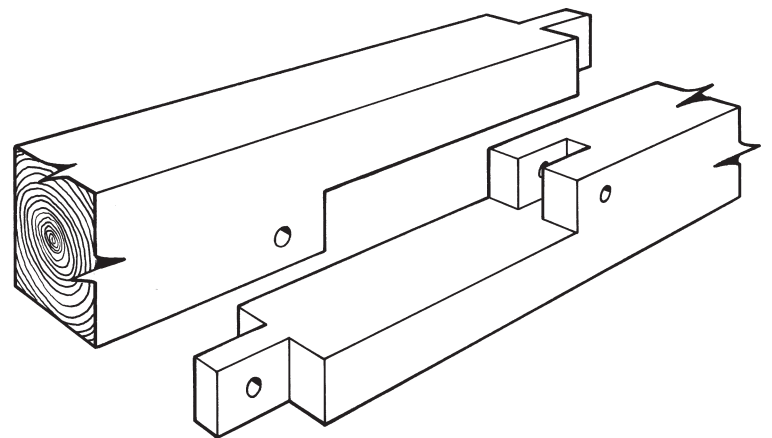
Fig. 19. A typical halved and bridled scarf. Additional pins may secure the lap.

Halved and Bridled. This not uncommon form (Fig. 19) works moderately well in all ways and yet is straightforward to fabricate and assemble. Undoubtedly there are splayed varieties of this scarf as well.

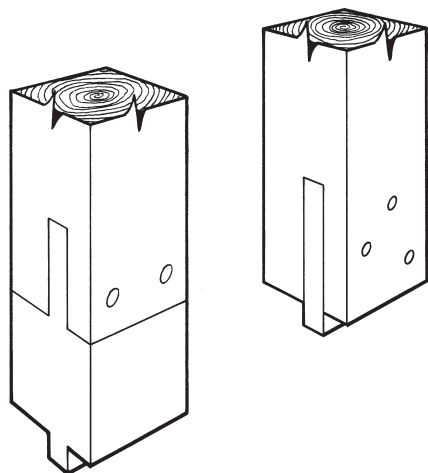
20.

Figs. 20-22. At top (20), post-bottom repairs: bridled scarf on left, free tenon on right. Middle (21), free tenon joins the posts of adjacent frames. Above (22), a stout pin kerfed and end-wedged does the same.

Bridled Repair Techniques. When early carpenters encountered posts with decayed bottoms, the simplest way to replace a short section of damaged wood was with the bridle. In this position, the joint was subjected to primarily axial compression. This short, easy to fabricate joint (Fig. 20, facing page), was more than adequate. If only the tenon was decayed, it could be replaced with a *free tenon* (Fig. 20), also called a slip tenon or faux tenon. The use of a free tenon also permitted members tenoned at both ends to be inserted into an already erect frame. In a few cases where a carpenter mistakenly cut a timber off at the shoulder rather than the end of the tenon, a free tenon allowed the piece to be saved.

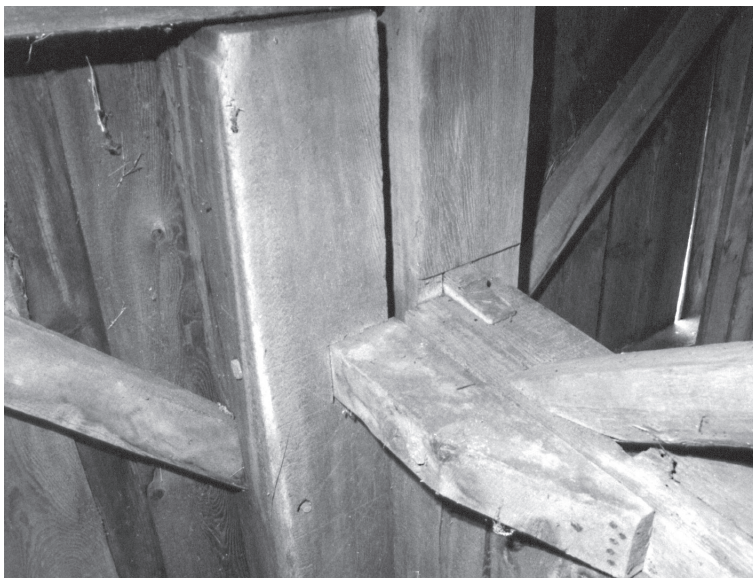
When the builder added to this barn in Savoy, Mass., he saved on a new 30-ft. tie beam by framing a piece into the post and pinning and nailing it to the existing barn's tie beam. Notice how the end is hewn down to permit better nailing.

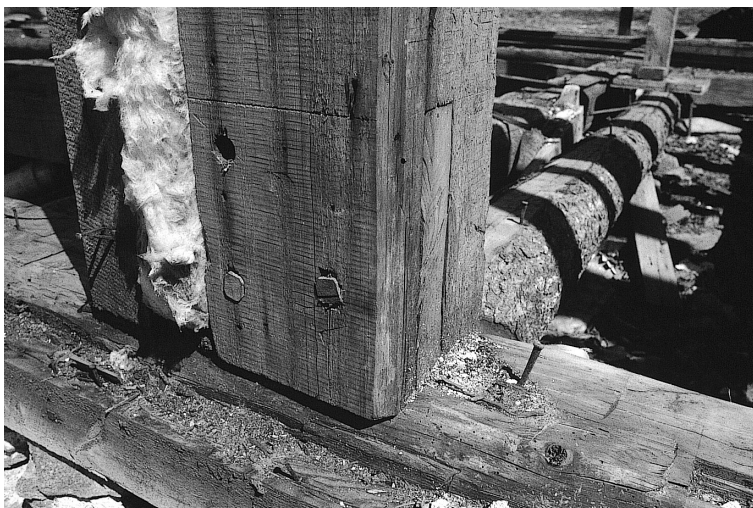
A free tenon in the bottom of a post in this house in Windsor, Mass., may be a repair or a fix for a mistake. Shadows are cast by joists above.

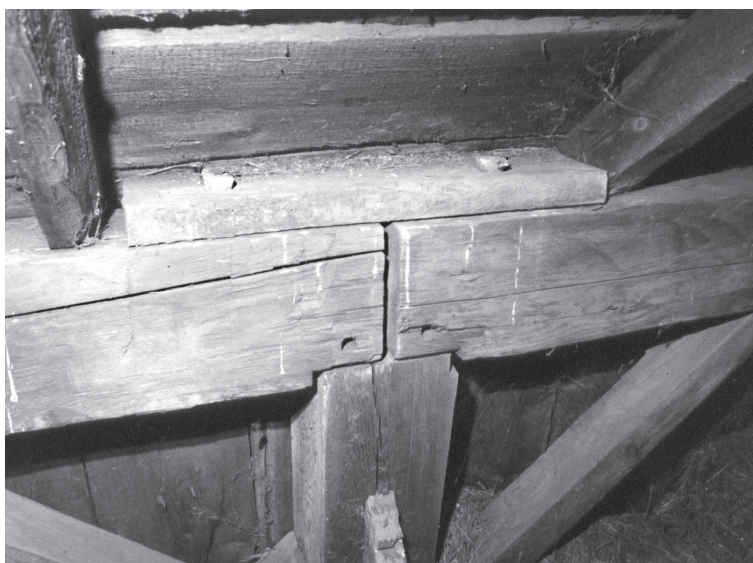
This strange arrangement in a barn in Rochester, Vermont, uses the post top tenon as a sort of free tenon to join the plates, though pins are invisible. The builder must have realized the inherent weakness of the connection and added the fish plate on top, secured with two pins.

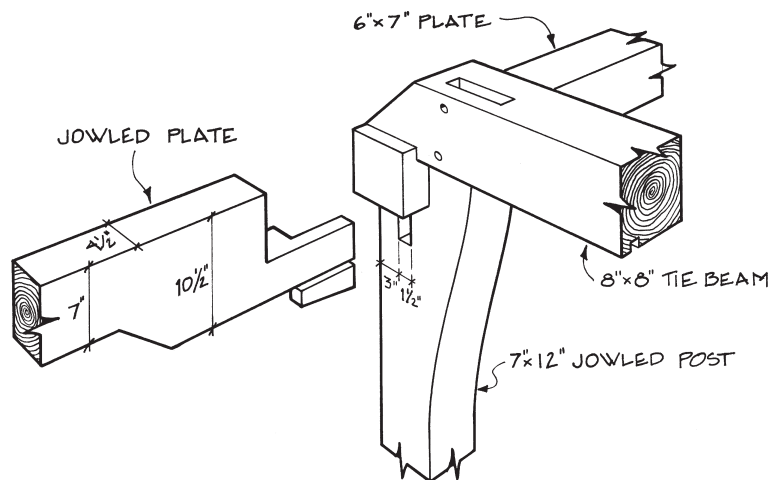
Fig. 23. Jowled plate of an early-18th-century addition to a barn in Seekonk, Mass. The mortise, offset in the post to avoid undercutting the post-to-plate tenon (hidden from view), was lengthened to allow easy insertion of the new plate tenon. The latter then was wedged up tightly under the existing plate. No pin was used.

If the plates and sills of the addition could be attached to the existing frame, then the builder saved the major expense of cutting an additional cross-frame. However, scarfing onto the end of an existing plate or sill was cumbersome and might compromise the original frame. The best solution was to utilize jowled members to offset the connection to an adjacent member (Figs. 23-25). The flared butt of the tree was retained during hewing or sawing. These jowled sills, plates and purlin plates required only simple mortises in the existing timbers, easily cut in place. Ten examples of such jowled members have been found in Massachusetts, New York and Vermont, from the early 18th century to the middle of the 19th.

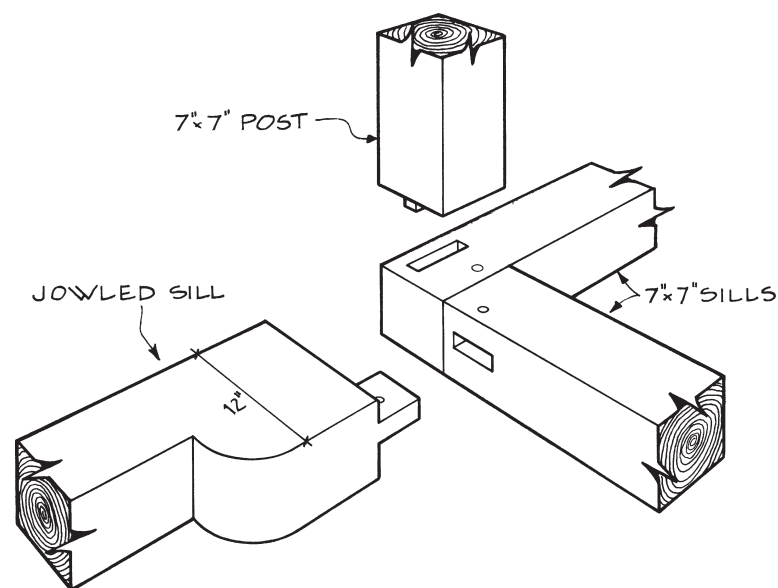
Fig. 24. In the same barn the sill was similarly jowled, but also pinned.

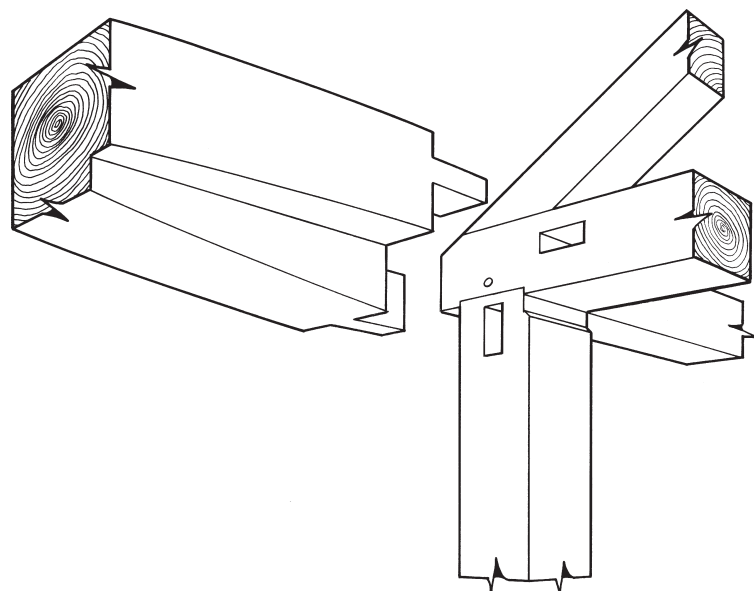
Fig. 25. A 9x9 plate, jowled in two directions to measure 12x13, joined an 1820-1860, 16x42-ft. carriage shed to a house in Rowe, Mass. The connections were unpinned and held in place by sheathing.

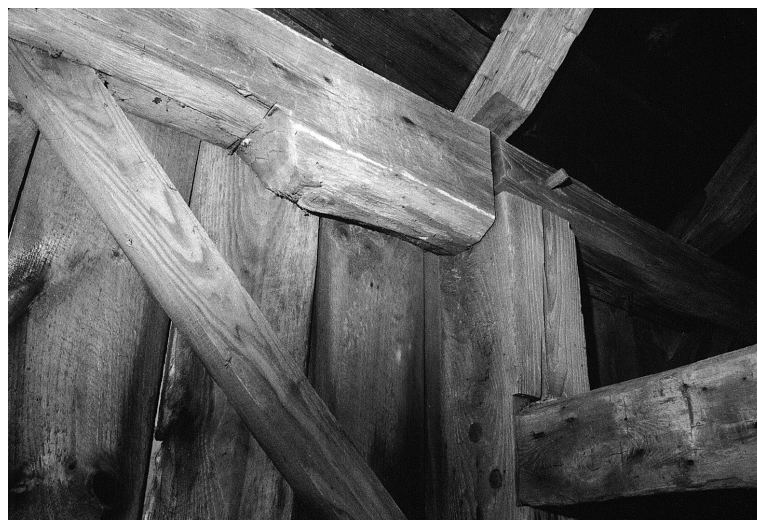
Jowled plate (one of six!) in a much-expanded 18th-century English-style barn, Huntington, Mass.

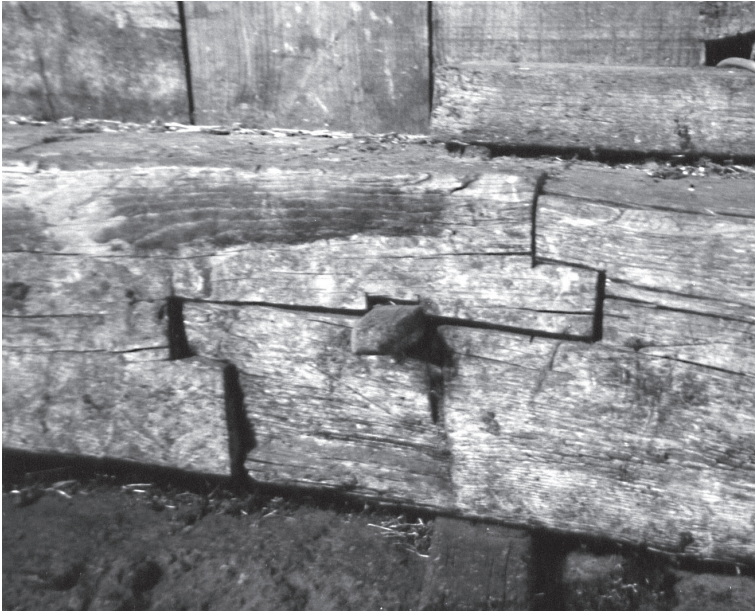
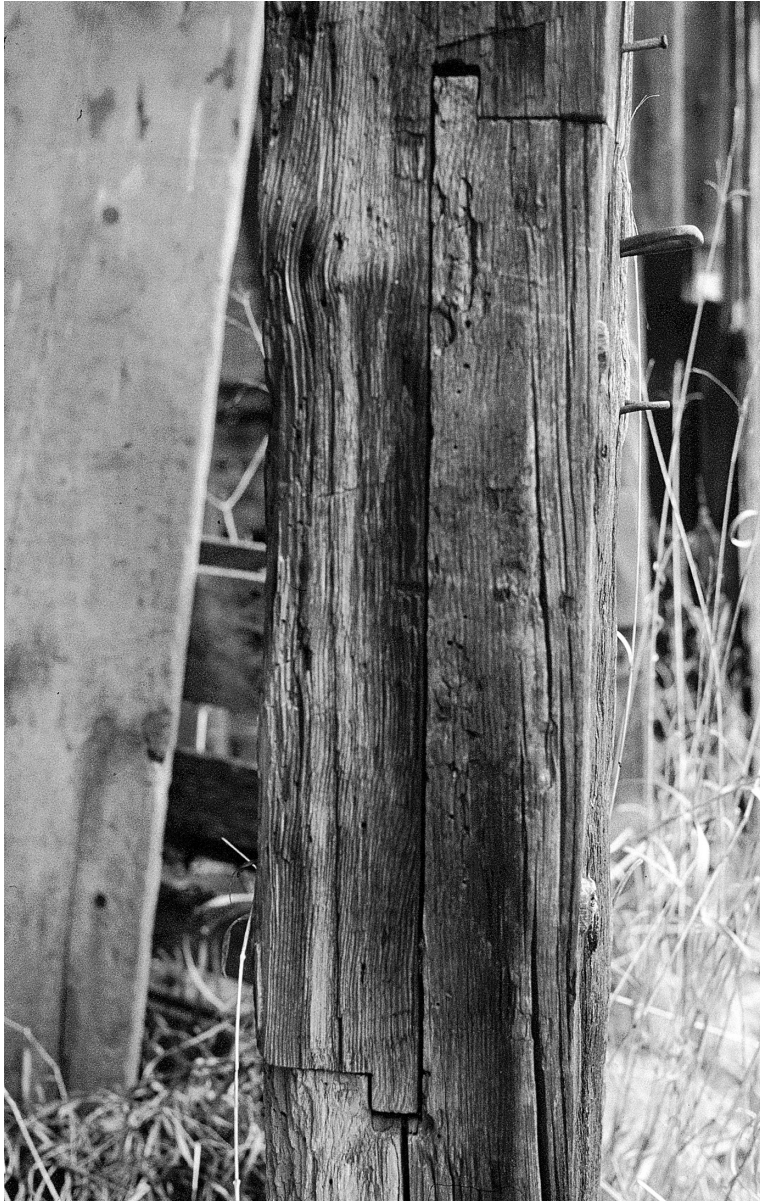
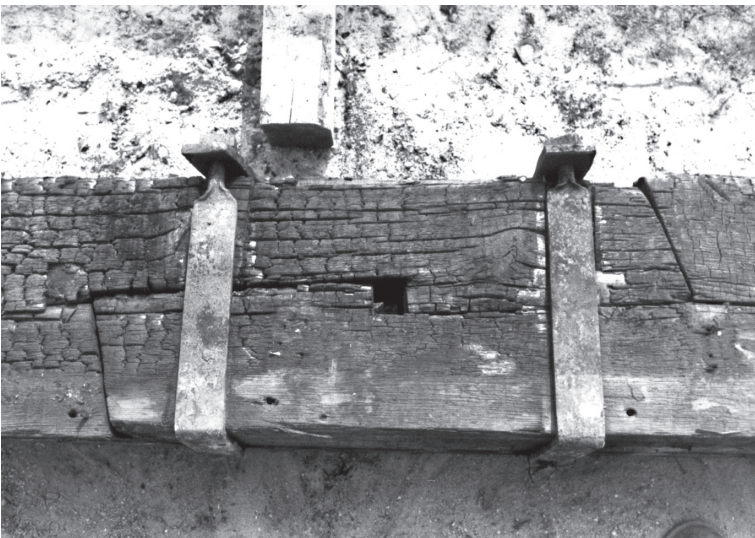
At top, bladed scarf with key, barn sill in Woodford, Calif. The sill is 8x8 Ponderosa pine, the scarf only 16 in. long. Top right, a bladed scarf used to repair a 7½ x 9½ post in a barn in Buskirk, N.Y. The tenons are 1 in. thick and 1 in. long, the scarf 23 in. long, with four pins. Above, a stop-splayed, undersquinted and tabled scarf with key used in a 6½ x 13 truss chord in the 1796 Cabildo in New Orleans (roof burned 1988, reconstructed 1992; see TF 21 and 24). There is barely a splay, and two forged iron straps still hold the joint together. At right, this unusual stop-splayed, undersquinted and tabled scarf in Pine Plains, New York, did not employ a key: the halves had to be slid together.
